NSWC TR 87-368

# **CORROSION/DETERIORATION OF FUEL TANK MATERIALS WETTED IN METHANOLIC ELECTROLYTES**

BY W. A. FERRANDO  
RESEARCH AND TECHNOLOGY DEPARTMENT

15 DECEMBER 1987

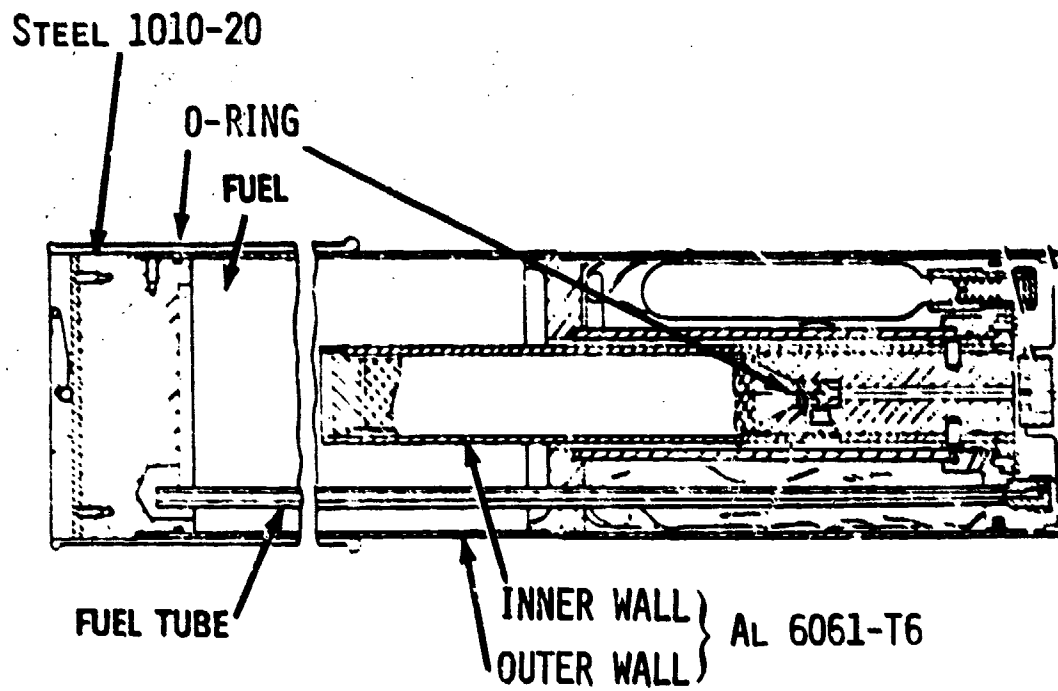
FIGURE 1. FUEL WETTED CAVITY COMPONENTS

The emphasis was on extended storage of the vessel in an O-ring sealed condition under potentially harsh environmental conditions. Thus, it was recommended that the mechanisms of galvanic and crevice corrosion be investigated for this system. In addition to temperature extremes, the storage locker is subject to occasional seawater incursions. The effect of a moisture laden partially wetting atmosphere surrounding the tank also became a significant consideration and was incidentally treated. The containing vessel must retain its integrity and the fuel shall not have leaked or decomposed during the anticipated storage period. Any corrosion by the fuel or surrounding atmosphere which jeopardizes this integrity would be considered unacceptable.

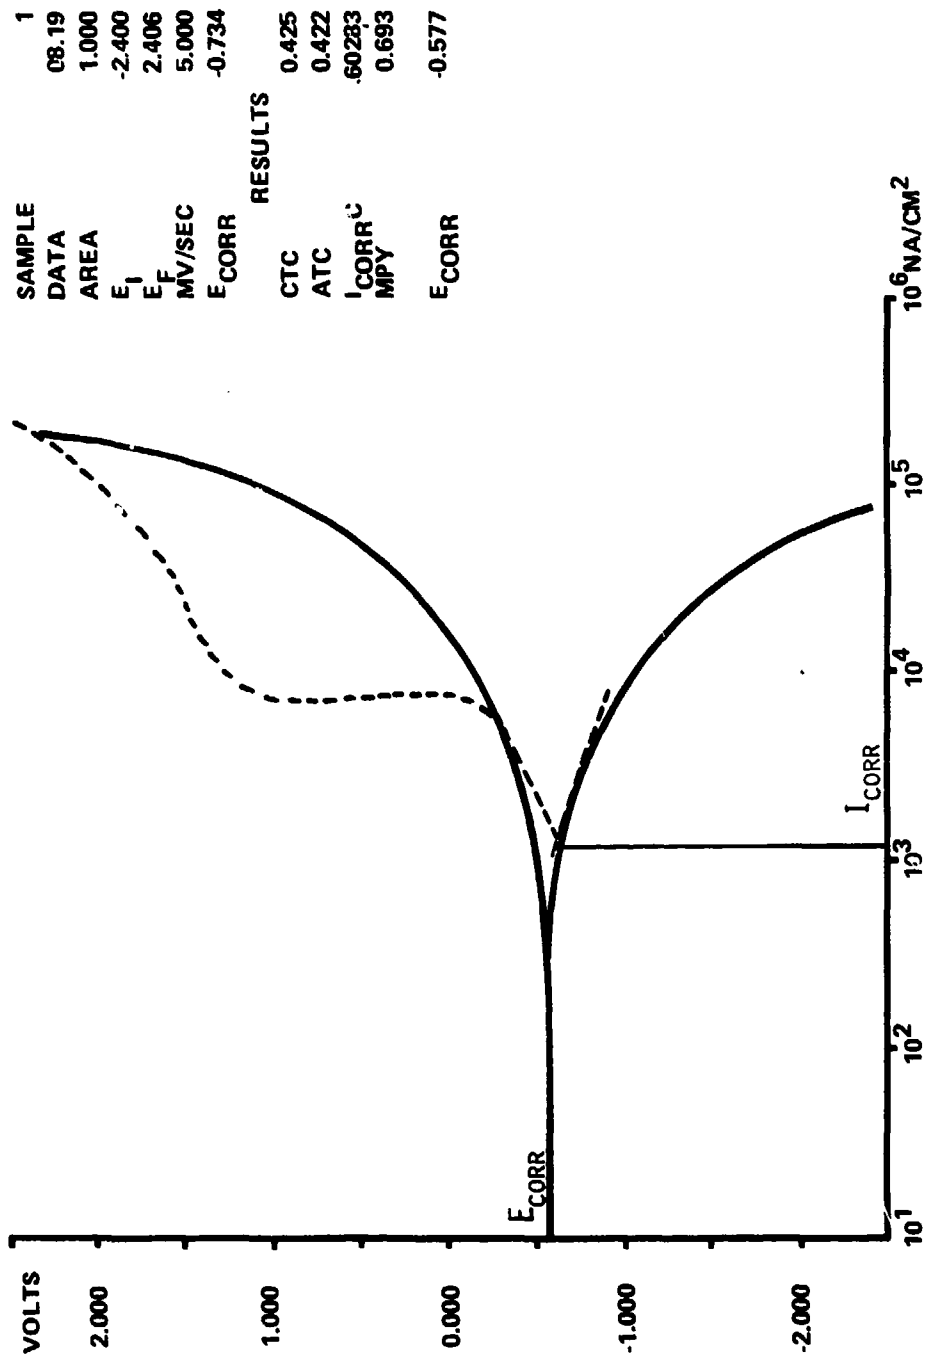
FIGURE 2. POTENTIODYNAMIC SCAN OF UNANODIZED 6061-T6 ALUMINUM IN FUEL MIXTURE CONTAINING CC1<sub>4</sub>

A test cell was fabricated using a graphite counterelectrode and calomel standard reference and filled with the fuel mixture. A polished aluminum sample was inserted into the cell and immediately scanned. Figure 2 shows the initial measurement on this sample. This curve is quite typical. In particular, the intersection of the limiting slopes (linear region) of its cathodic and anodic branches, as the applied potential passes through 0, defines the metal's corrosion potential  $E_{corr}$ . This provides a value of corrosion current for the freely corroding metal, as indicated in Figure 2. Taken with physical information, this measured corrosion current can provide a value of uniform corrosion rate for the metal.

The anodic portion of the scan often will show a "passive" region (dotted addition in Figure 2), within which the current does not increase with increasing potential. This indicates a regime of surface protection, usually by an adherent oxide layer. Above this plateau, the protection breaks down and the corrosion current increases rapidly, often with the onset of pitting. In the present case, fairly wide ranging cathodic to anodic scan was employed. This was done specifically to place the test surface in a particularly corrosion vulnerable condition. If the "electrolyte" were to have a detrimental effect on the aluminum, such a scan would reveal it.

The corrosion rate as determined from the initial scan (Figure 2) was quite moderate [ $<1$  mil/year (mpy)]. The low measured corrosion current of  $1.6 \times 10^3$  nanoamps reflects the liquid's relatively low initial electrical conductivity. By way of comparison, an aluminum sample run in distilled water produced a corrosion current of  $0.5$ - $1.9 \times 10^2$  nanoamps. Typical corrosion currents observed in acidic electrolytes are several orders of magnitude larger. No anodic passivity was observed. Of particular concern, was the visible pitting almost immediately initiated on the anodic portion of the scan. A dark localized corrosion product emanated from the pits. Upon performing a second scan, it became evident that the pitting corrosion was extremely severe. The chemical action continued even after the potential was removed. This was the case despite a still relatively low calculated corrosion rate ( $\sim 2$  mpy). This finding points out the importance of visual observation to supplement the scans in a complete assessment of corrosion performance. Figure 3 shows the very severe pitting experienced by the aluminum during the pd scans. At this point, a serious incompatibility was obvious and further pd scans in the fuel mixture were suspended.

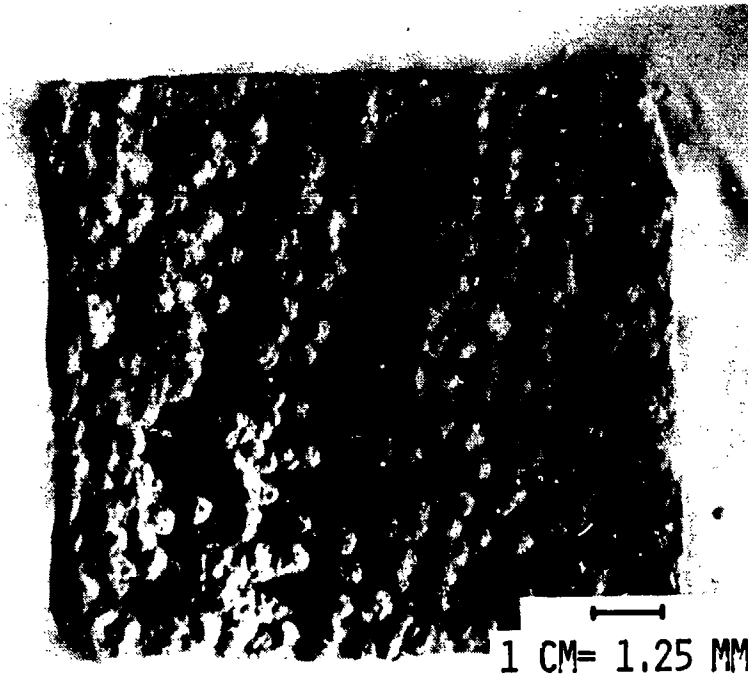
FIGURE 3. SURFACE OF UNANODIZED 6061-T6 ALUMINUM BEFORE AND AFTER POTENTIODYNAMIC SCANS IN FUEL MIXTURE CONTAINING  $\text{CCl}_4$

Since severe pitting immediately revealed itself the dominant corrosion process here, it seems appropriate to render a brief general discussion of the subject before seeking the particular mechanism at work in the solvent.

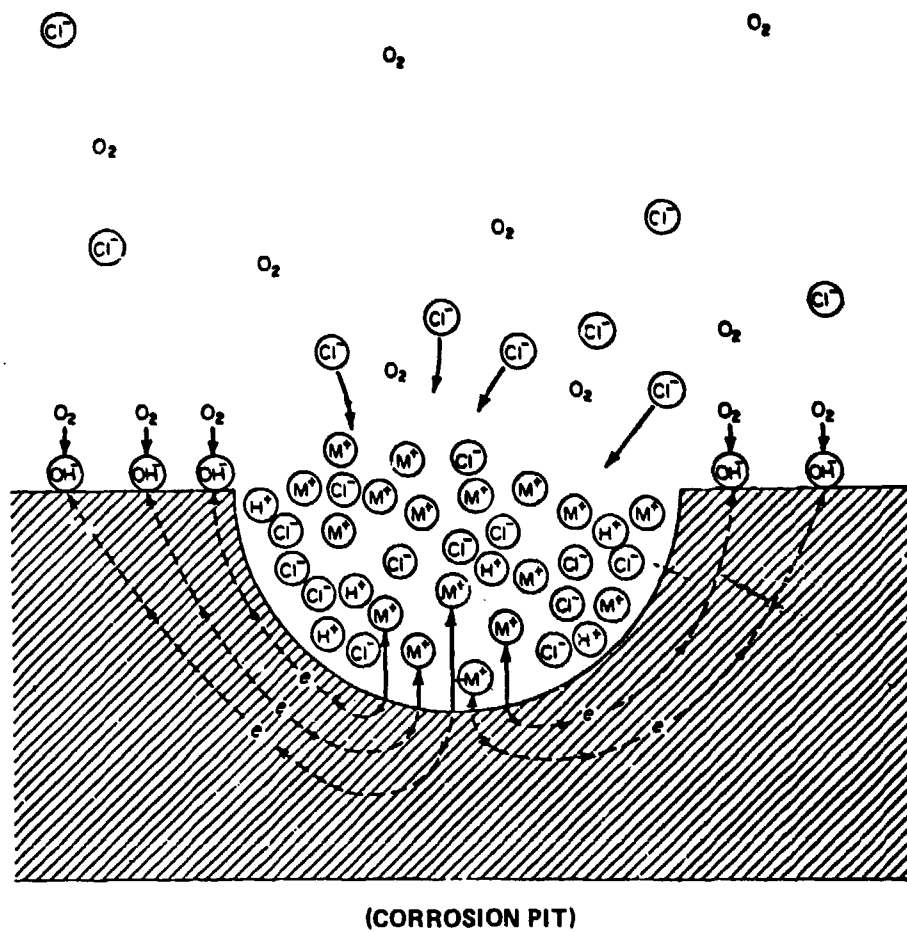
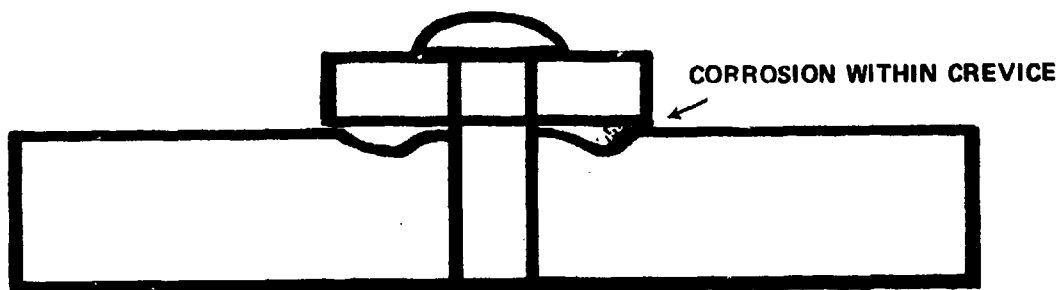
FIGURE 4. SCHEMATIC REPRESENTATIONS OF PITTING CORROSION AND CREVICE CORROSION

The pitting mechanism can be considered an autocatalytic process. That is, the corrosion processes within the pit produce conditions which are both stimulating and necessary for continuing activity and propagation. This is illustrated schematically in Figure 4(upper). Here the Al metal, designated M, is being pitted by a chloride solution. Rapid dissolution occurs within the pit, while oxygen reduction takes place on adjacent surfaces. This activity is self-stimulating and self-propagating. This rapid dissolution of metal tends to produce an excess of positive charge in the area, resulting in the migration of chloride ions to maintain electroneutrality. Thus, in the pit, there is a high concentration of  $AlCl_3$  and, as a result of hydrolysis, a high concentration of hydrogen ions. Both hydrogen and chloride ions stimulate the dissolution of aluminum and the entire process accelerates with time. Since the solubility of oxygen is virtually zero in concentrated solutions, negligible oxygen reduction occurs within the pits. The cathodic oxygen reduction on the surfaces adjacent to the pits tends to suppress corrosion. In a sense, pits cathodically protect the rest of the metal surface.

The O-ring groove area constitutes a crevice which may trap and concentrate stagnant corrosive compounds from the electrolyte. This is shown schematically in Figure 4(lower). These compounds could preferentially corrode the groove area, causing leaks in the system. An elevated temperature test was designed and carried out to examine this possibility. At the same time, some information accrued on compatibility of the O-ring material itself. This information is necessarily qualitative and limited in scope to compatibility of the given test material. Such data is actually incidental to a corrosion test, but has been included in this section because of its important consequences in the device involved.

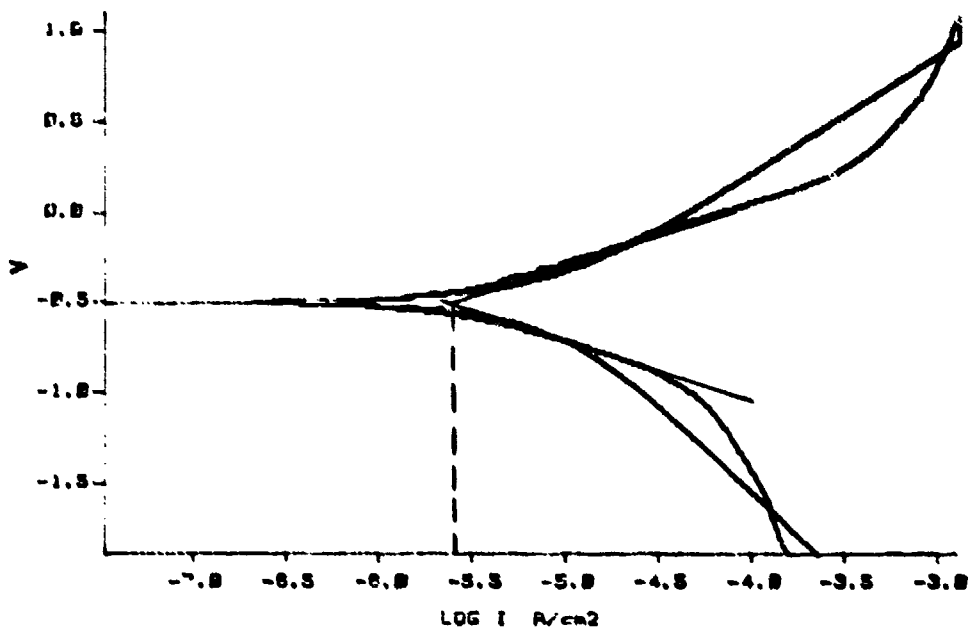
POTENTIODYNAMIC					
DATE CREATED	21	OCT	1986	RUN DATE	21 OCT 1986
IR COMP	=	DISABLED		TAFEL BETA a	= 0.662 V/DEC
FINAL E	=	1.0 V ~ Ec		TAFEL BETA c	= 0.977 V/DEC
INITIAL E	=	-1.2 V ~ Ec		Ecorr	= -0.690 V
INITIAL DELAY	=	60 SEC		E(I=0)	= -0.496 V
SCAN RATE	=	2 mV/SEC		Icorr	= 8 E-6 A/cm²
				CORR RATE	= 4 ED MPY
				(Parcalc)	
EQUIV WEIGHT	=	9 g/EQUIV		Icorr	= 2.5 E-6
DENSITY	=	2.7 g/cm³		CORR RATE	= 1.25 MPY
AREA	=	1 cm²			(Direct measurement)

FIGURE 8. POTENTIODYNAMIC SCAN OF UNANODIZED 6061-T6 ALUMINUM IN METHANOL

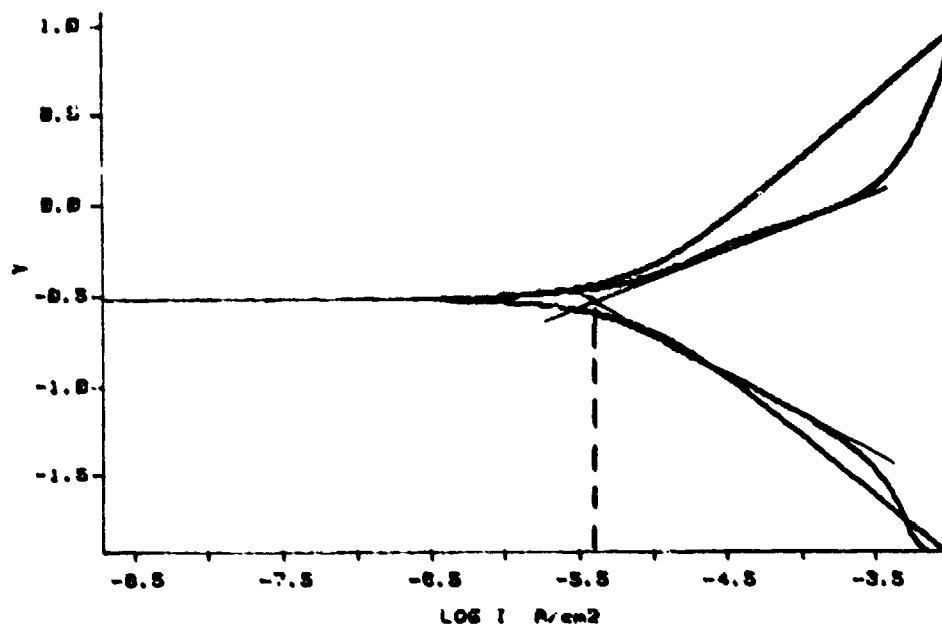
POTENTIODYNAMIC					
DATE CREATED	22	OCT	1986	RUN DATE	22 OCT 1986
IR COMP	=	DISABLED			
FINAL E	=	1.0 V ~ Ec			
INITIAL E	=	-1.2 V ~ Ec			
INITIAL DELAY	=	60 SEC			
SCAN RATE	=	2 mV/SEC			
EQUIV WEIGHT	=	27.9 g/EQUIV			
DENSITY	=	7.8 g/cm3			
AREA	=	1 cm2			
				TAFEL BETA a	= 0.693 V/DEC
				TAFEL BETA c	= 0.671 V/DEC
				Ecorr	= -0.729 V
				E(I=0)	= -0.515 V
				Icorr	= 7 E-6 A/cm2
				CORR RATE	= 3 ED MPY
				(Parcalc)	
				Icorr	= 4.5 E-6
				CORR RATE	= 1.93 MPY
				(Direct measurement)

FIGURE 9. POTENTIODYNAMIC SCAN OF ZINC-PLATED STEEL IN METHANOL

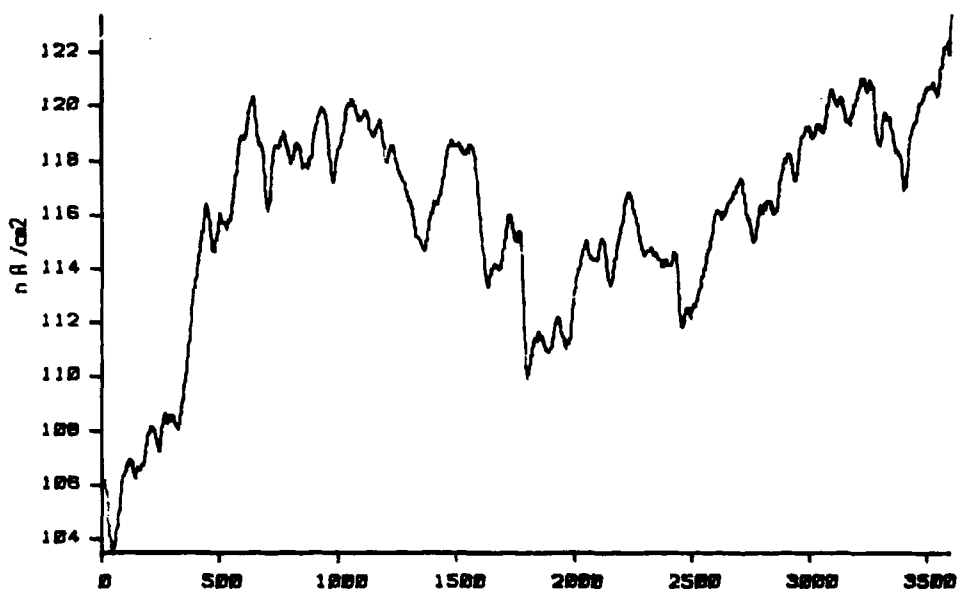
GALVANIC CORROSION			
DATE CREATED	9 JUN 1987	RUN DATE	9 JUN 1987
RUN TIME	= 3600 SEC		
EQUIV WEIGHT	= 9 g/EQUIV	E <sub>corr</sub>	= -0.1 V
DENSITY	= 2.81 g/cm <sup>3</sup>	E[ <i>I</i> =0]	= 0 V
AREA	= 20.6 cm <sup>2</sup>

FIGURE 11. ALUMINUM-STEEL GALVANIC COUPLE CORROSION SCAN: GALVANIC CURRENT VERSUS TIME IN METHANOL

Figure 11 is an output scan of current versus time for the couple taken on the Corrosion Console. Such monitoring scans were made frequently during the test. The average current was extracted from each scan and used to plot Figure 12. Figure 12 shows the galvanic current in nanoamps/cm<sup>2</sup> versus time in hours over the entire test period. The cell was connected to the measurement instrument with polarity assuming the aluminum electrode to be anodic. Thus the designation on the current axis refers to this electrode. The results show that, through about the first 400 hours, the aluminum was actually cathodic. The steel, therefore, was the corroding (anodic) member during this period. This was not unexpected, however, since the zinc plating should act as a sacrificial electrode. After the zinc has dissolved, the galvanic current may be expected to reverse.

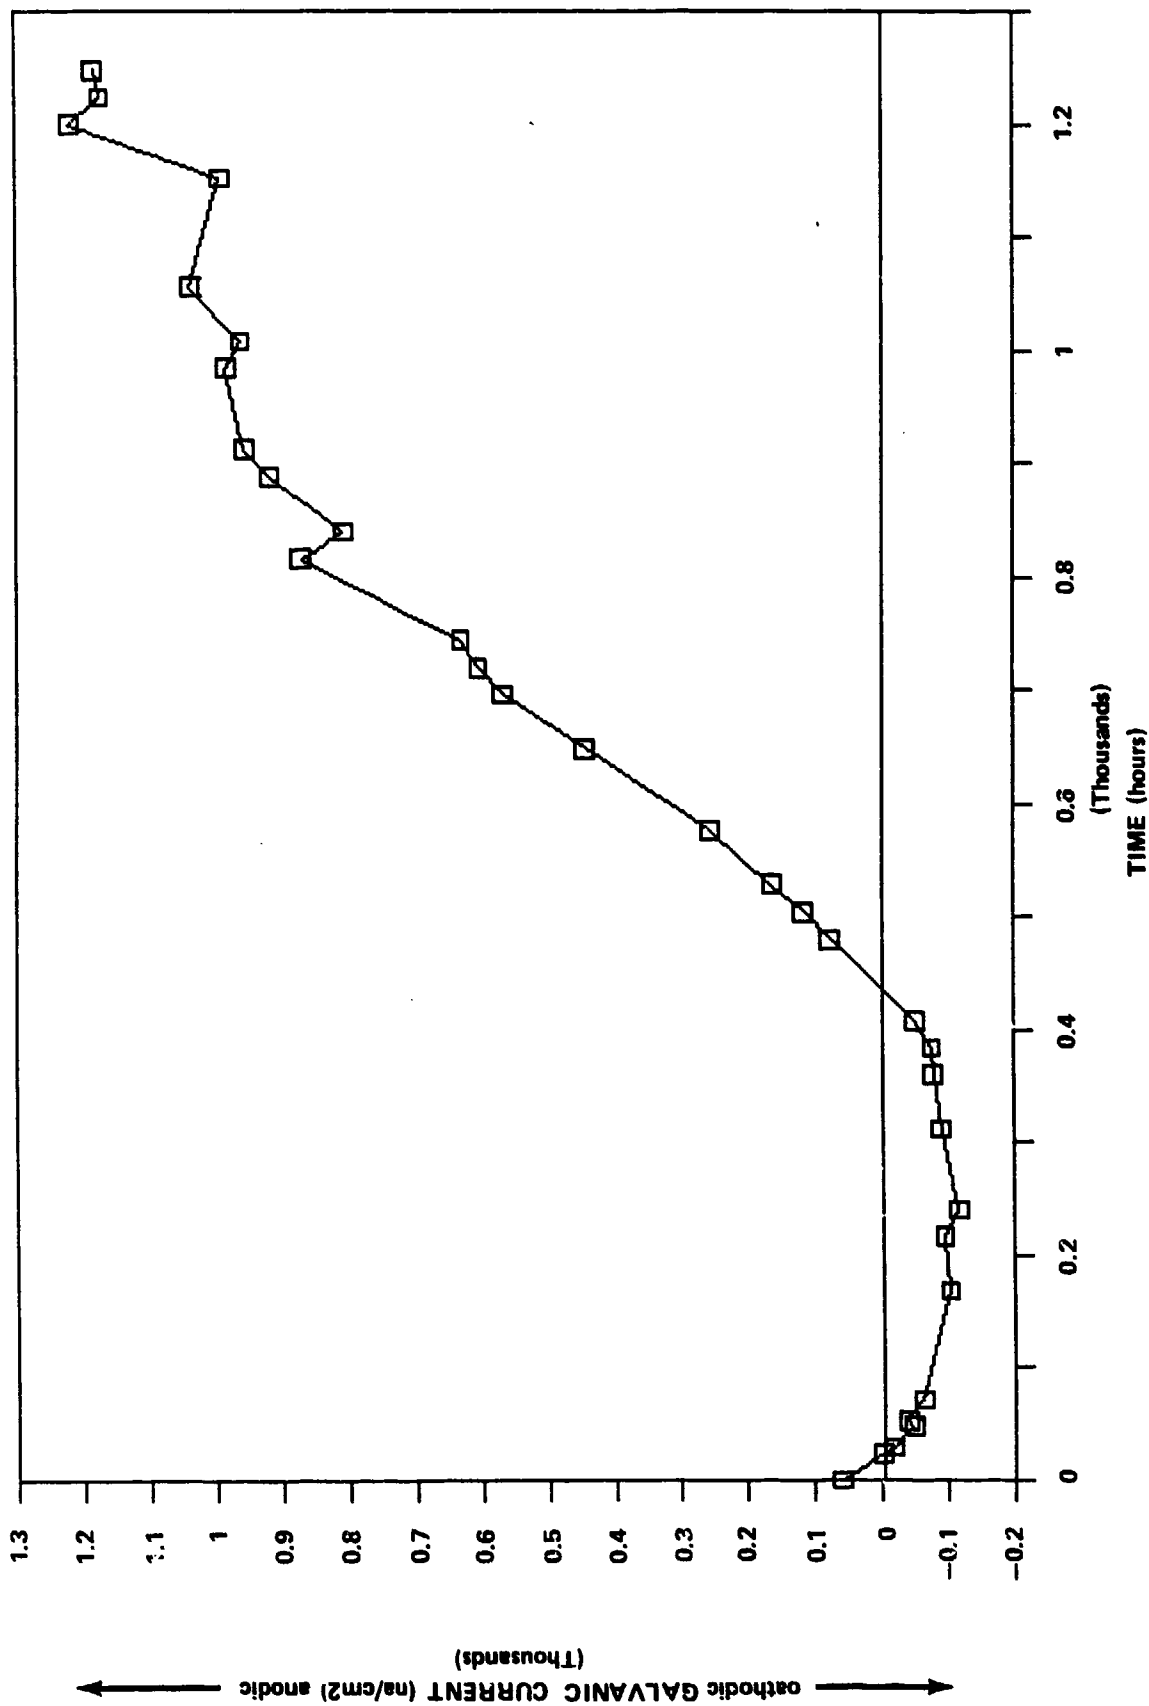
FIGURE 12. GALVANIC CURRENT DENSITY VERSUS TIME FOR ZINC-PLATED STEEL/6061-T6 ALUMINUM COUPLE IN METHANOL

The aluminum becomes anodic. The galvanic current subsequently continues to increase, saturating at 1-1.2 microamps/cm<sup>2</sup> after about 1000 hours exposure. The saturating behavior indicates the possible gradual formation of a partially protective thick oxide layer on the aluminum. Figure 13 shows the corrosion potential  $E_{corr}$  versus time. The sign change at 400 hours and limiting negative trend toward the conclusion of the test confirm the conclusions above. The apparent instability of  $E_{corr}$  at this point might indicate some breakdown or defects in the developed protective oxide film. By way of comparison, Figure 14 shows the same galvanic couple in a 3.5% NaCl electrolyte.\* The corrosion current density is some 15-20X larger in this case. It is shown below that even this rate of corrosion is not serious, provided significant pitting is not occurring.

The measurements of Figure 12 indicate a saturating galvanic current of 1.0 to 1.2 microamps/cm<sup>2</sup> at the aluminum member which is the predominant corroding (anodic) component after dissolution of the zinc plating on the steel. Computation of the corresponding corrosion rate in milli-inches/year (mpy) is as follows:

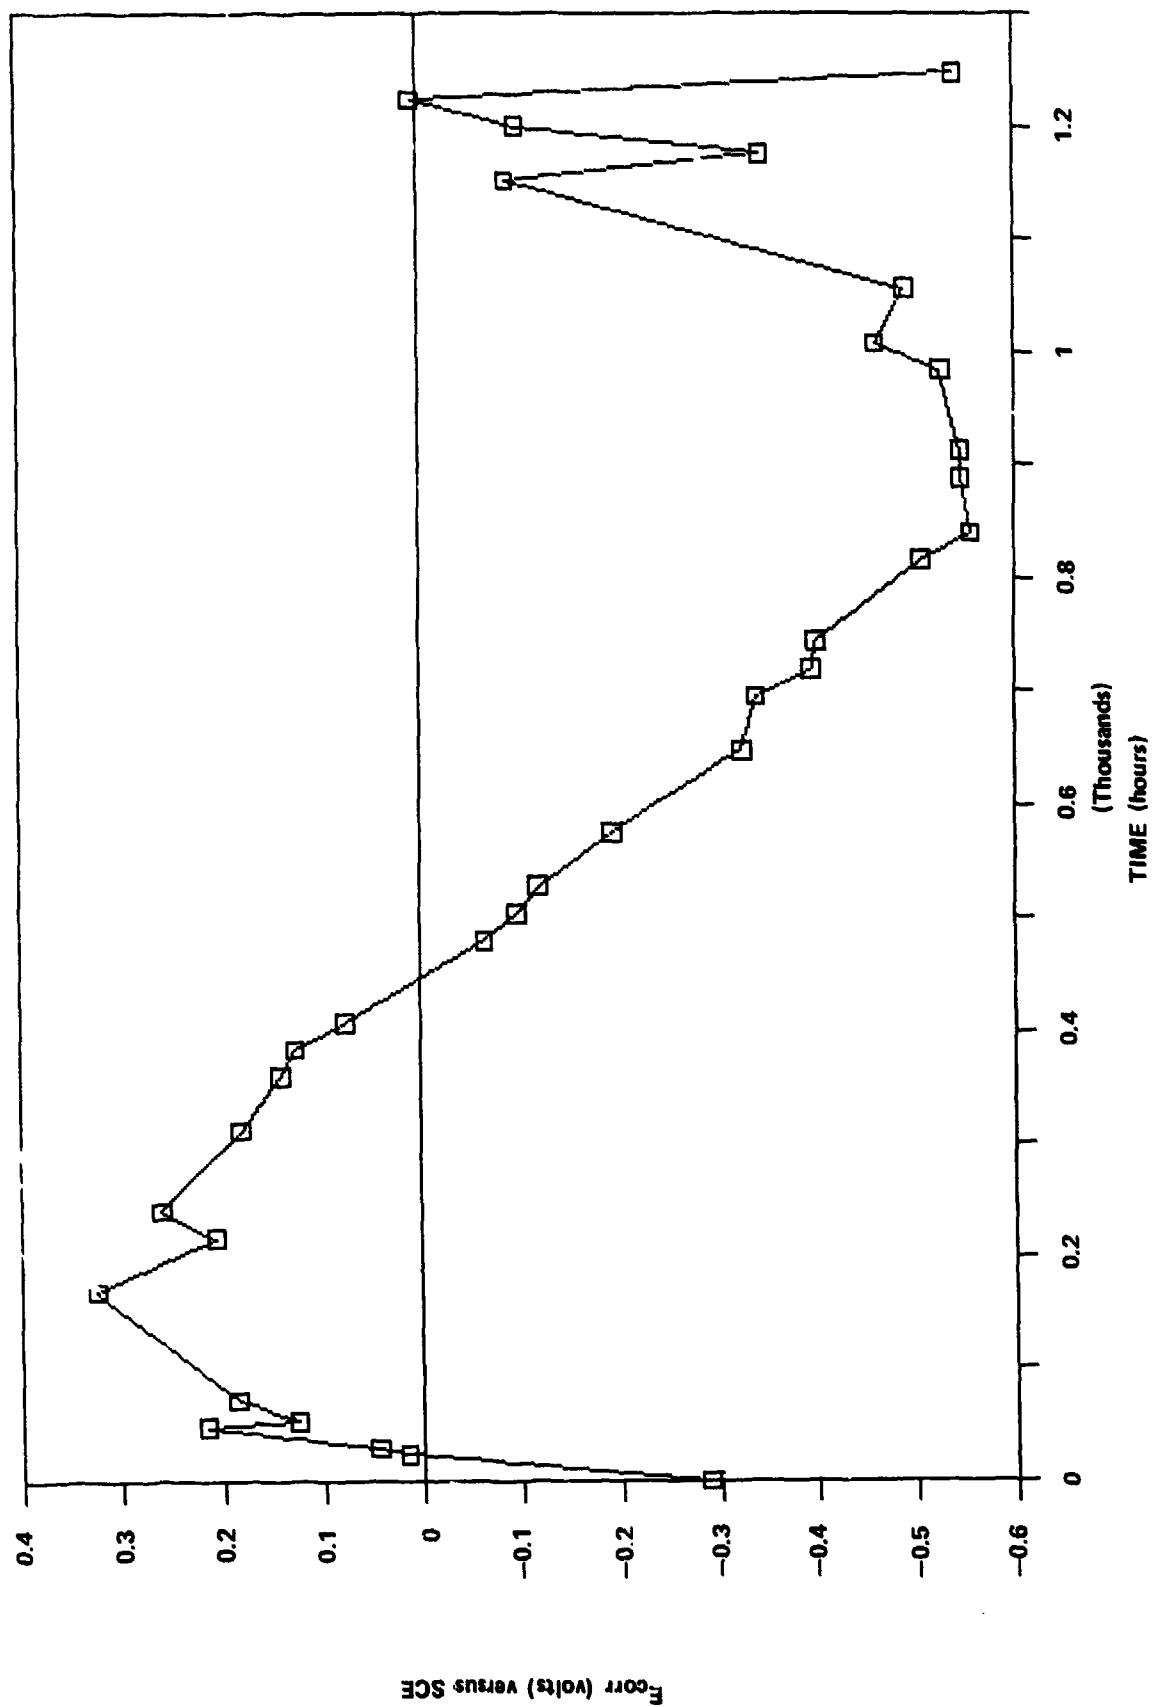
FIGURE 13. CORROSION POTENTIAL  $E_{corr}$  VERSUS TIME FOR ZINC-PLATED STEEL/6061-T6 ALUMINUM COUPLE IN METHANOL

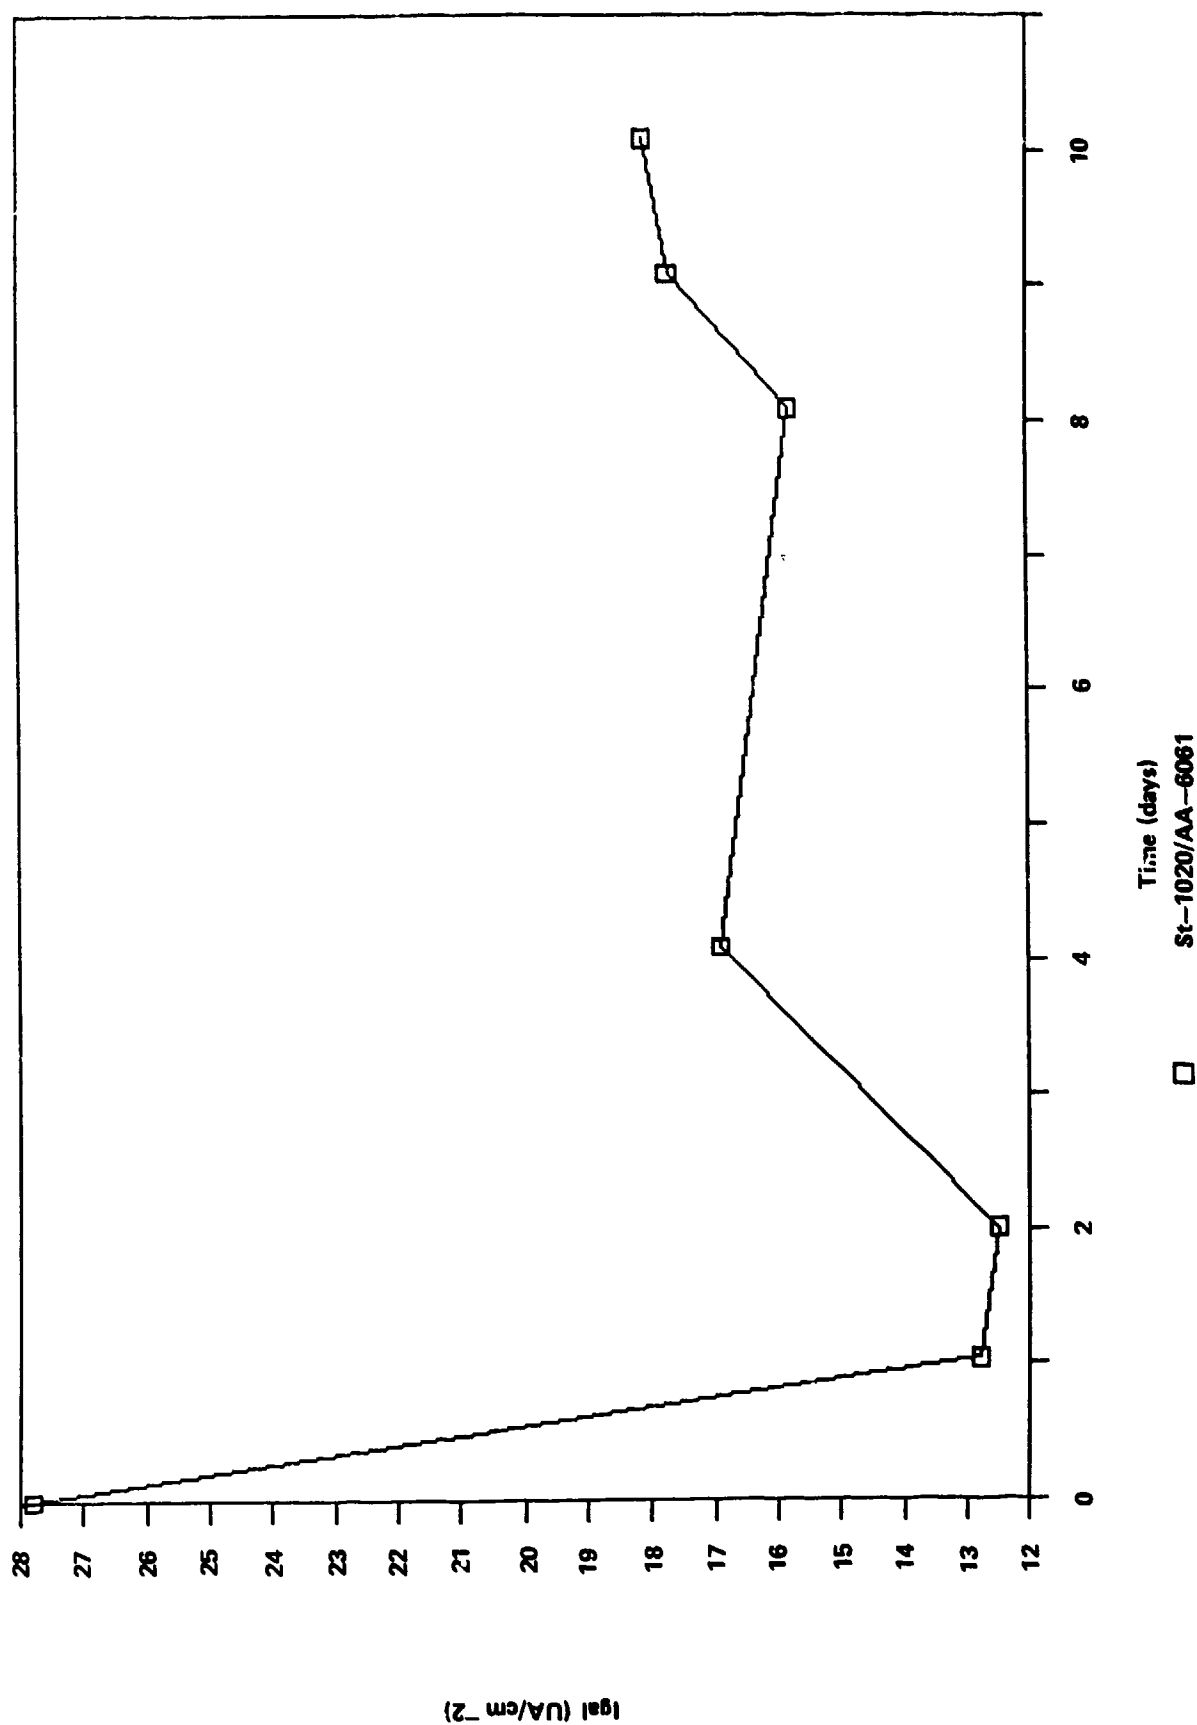
FIGURE 14. GALVANIC CURRENT DENSITY VERSUS TIME FOR 1020 STEEL/6061-T6 ALUMINUM COUPLE IN 3.5% NaCl SOLUTION

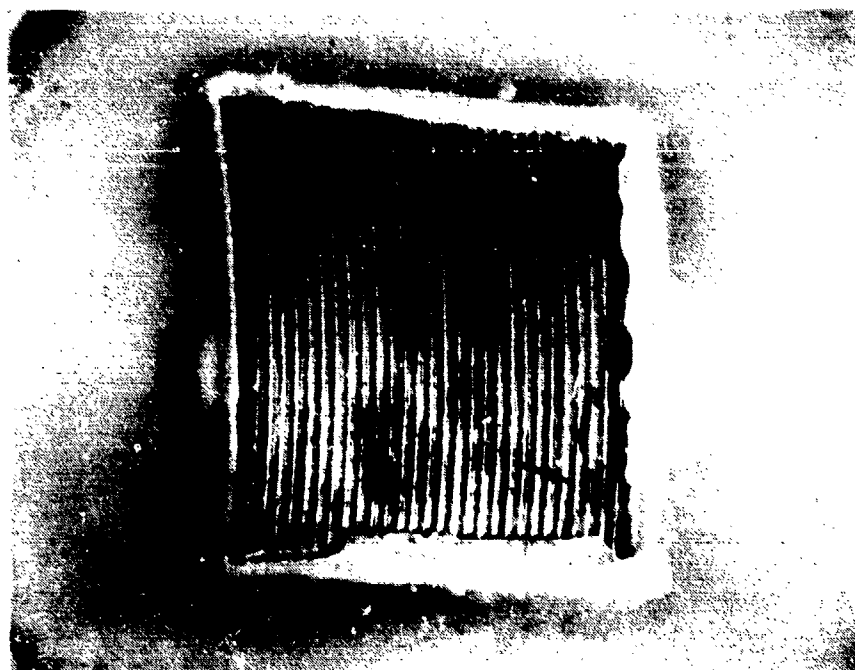
**FIGURE 15. ZINC-PLATED STEEL SURFACE BEFORE AND AFTER GALVANIC CORROSION TEST IN METHANOL**

Figure 15 shows the mounted steel sample before (top) and after (bottom) the test. The masking paint has been removed from the post test sample, revealing the cut sample edges. Although corrosion activity has taken place beneath the masked portion, the arrows point out small sections of zinc plating remaining. The removal of the zinc, therefore, from the exposed surface correlates with the change in polarity of the galvanic corrosion current at 400 hours (Figure 12).

Probably more importantly, the couple was examined for evidence of pitting at the test termination. Figure 15 indicates no pitting of the steel electrode. Figure 16 shows the same enlarged surface area of the aluminum electrode before (top) and after (bottom) the test. Detailed examination indicates no pitting. Even scratches remain virtually identical in appearance after the test. Pitting, therefore, as a component of the galvanic corrosion of the metals in methanol does not seem to be a problem.

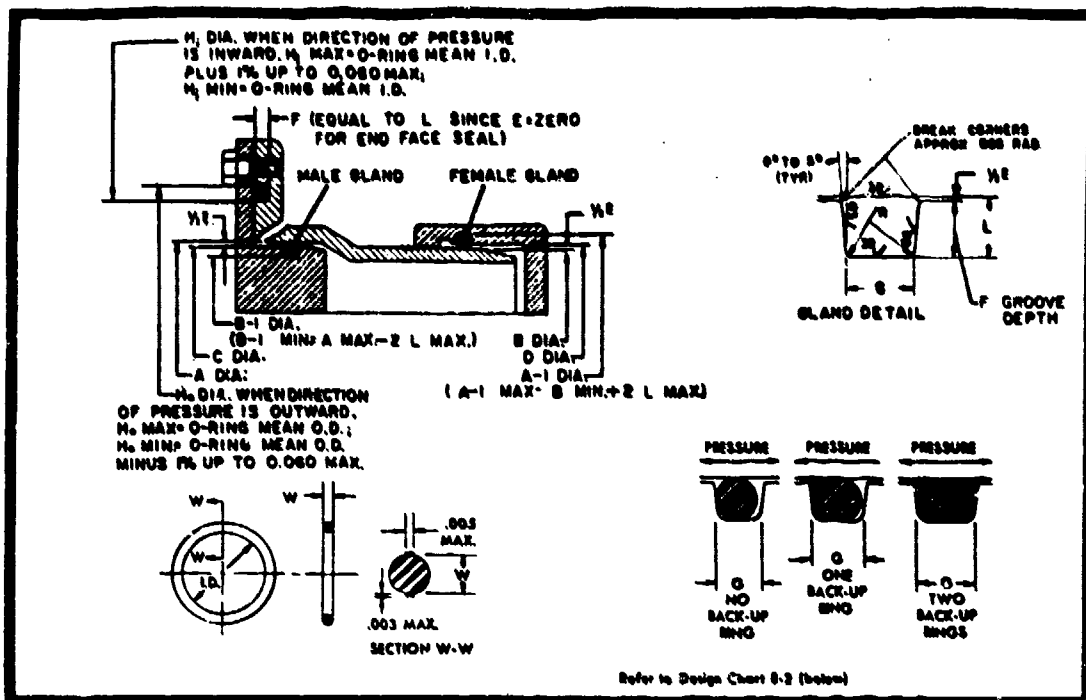
(A) INDUSTRIAL O-RING SEAL GLANDS

Four small vessels about 3 inches in length, consisting of 6061-T6 aluminum canisters about 3 inches long were fabricated with mating steel 1018 caps. The cans and caps were sized to fit with proper O-ring tolerance. Likewise, the O-ring groove was machined into the steel cap according to the specifications for the given O-ring found in Figure 17. The tops were made with four threaded holes above the groove for holding them firmly in place with small screws, against the internal pressure of some 15 lbs/in<sup>2</sup> at 70°C. This configuration reproduces the device fuel chamber, in scale, with reasonable accuracy. The O-ring size was that used between fuel chamber and gas generator in the actual device.

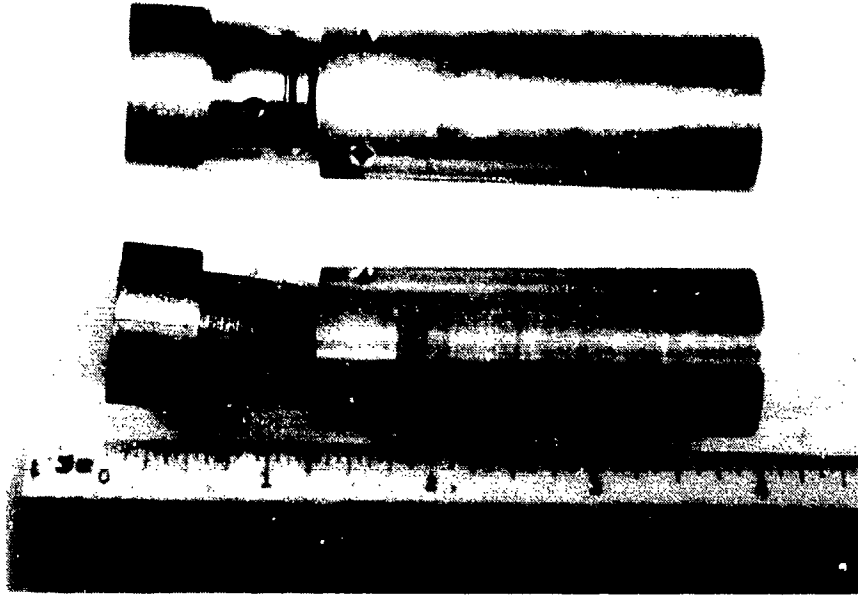
**FIGURE 18. 1018 STEEL/6061-T6 ALUMINUM VESSELS FABRICATED FOR CREVICE CORROSION TEST IN METHANOL**

graphs of the test container O-ring groove areas were taken before filling. The surfaces of the remaining two vessels were intentionally left untreated. Figure 18 shows a pair of these vessels. The difference in appearance of the surface treated container on the left may be noted.

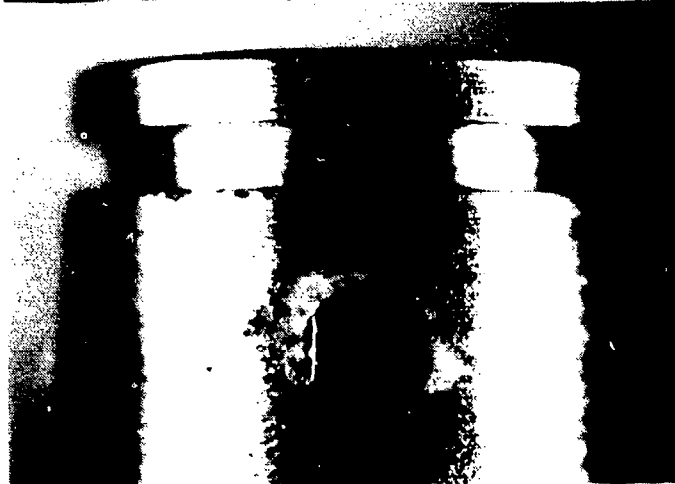
FIGURE 19. ZINC-PLATED STEEL CAP, BEFORE AND AFTER CREVICE CORROSION TEST, ARGON FILL AND AIR FILL

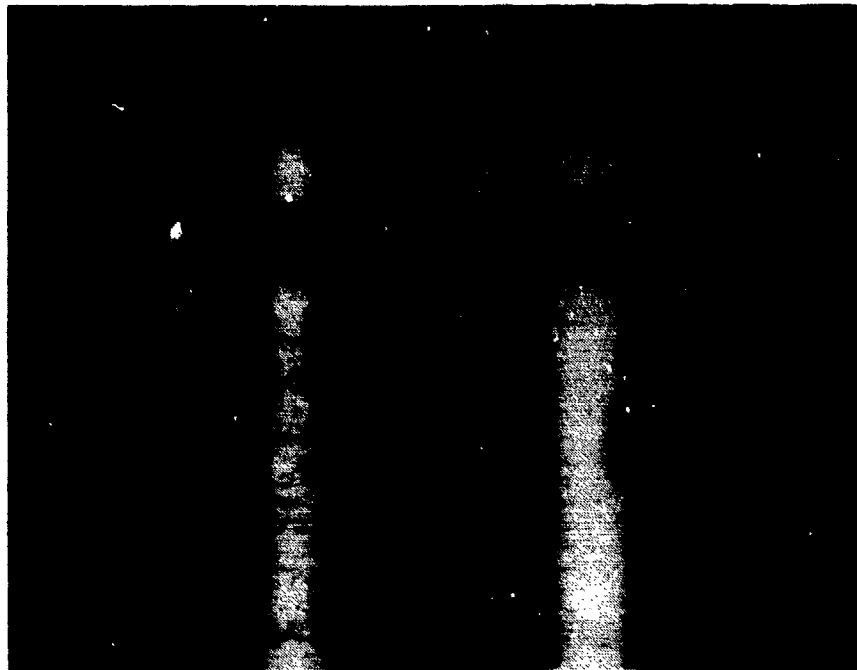
FIGURE 21. UNPLATED 1081 STEEL CAP BEFORE AND AFTER CREVICE CORROSION TEST
